These residents were not happy. Literal lakes had formed above their heads and every seam on this SBS roof was a potential failure. The drainage no longer performed properly, the material was buckling and leaks were occurring.

The management company needed a solution fast and couldn't evacuate tenants to perform a re-roof. As the insulation and structure were remediated internally, Weatherskin set out to remove all the seams and leaks immediately by going over-top of the old substrate with our flat roof, 5-layer system.

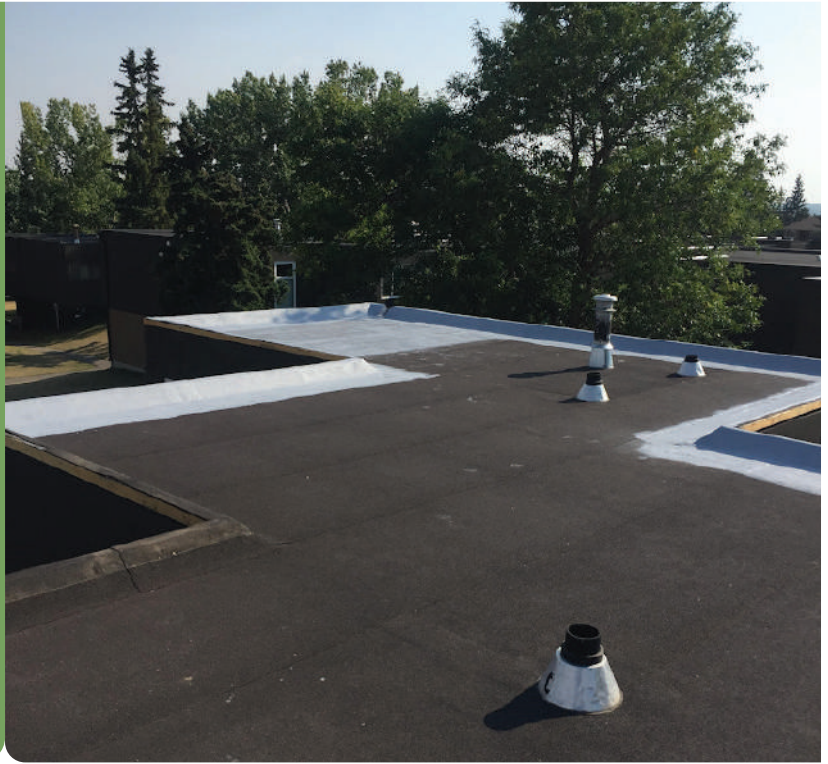
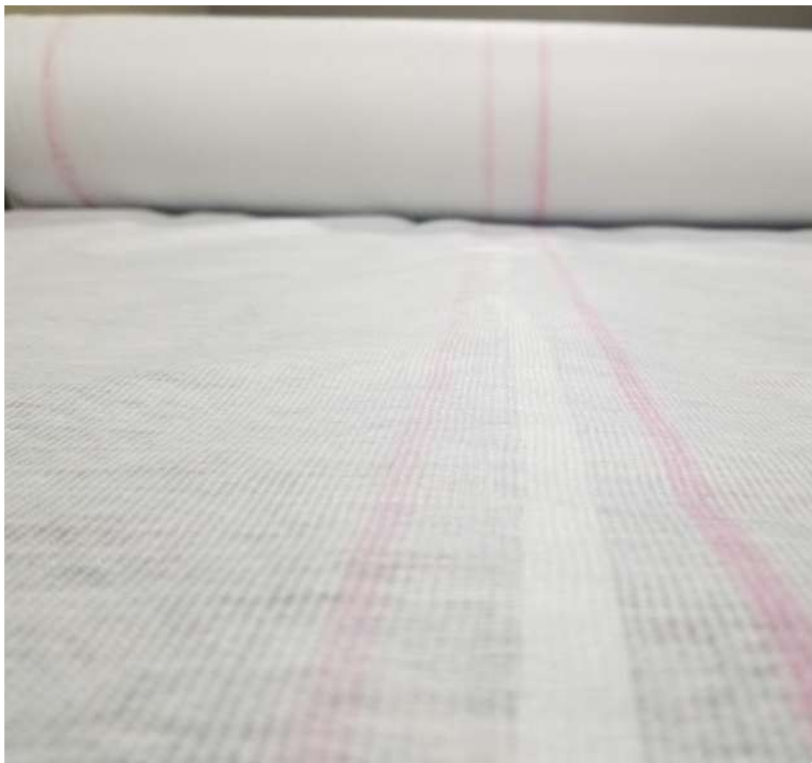
All of the flashings were removed and the trouble spots were flooded with Weatherskin day 1. The verticals, scuppers, drains and vents were attended to immediately afterwards. The Weatherskin team stopped the immediate problem by day 2 on the job and was ready to get to work on applying the complete system.

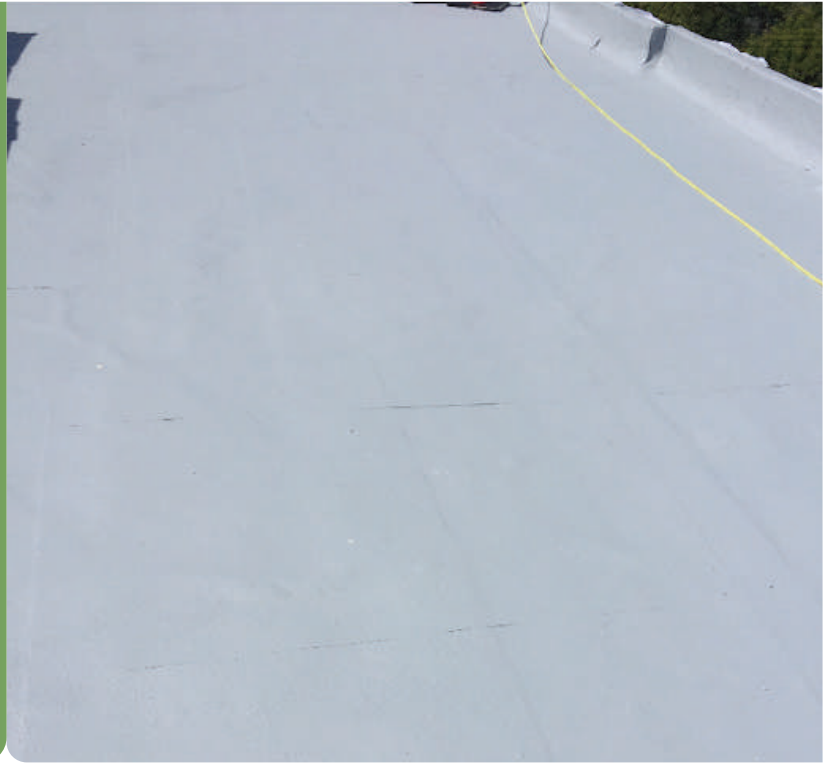
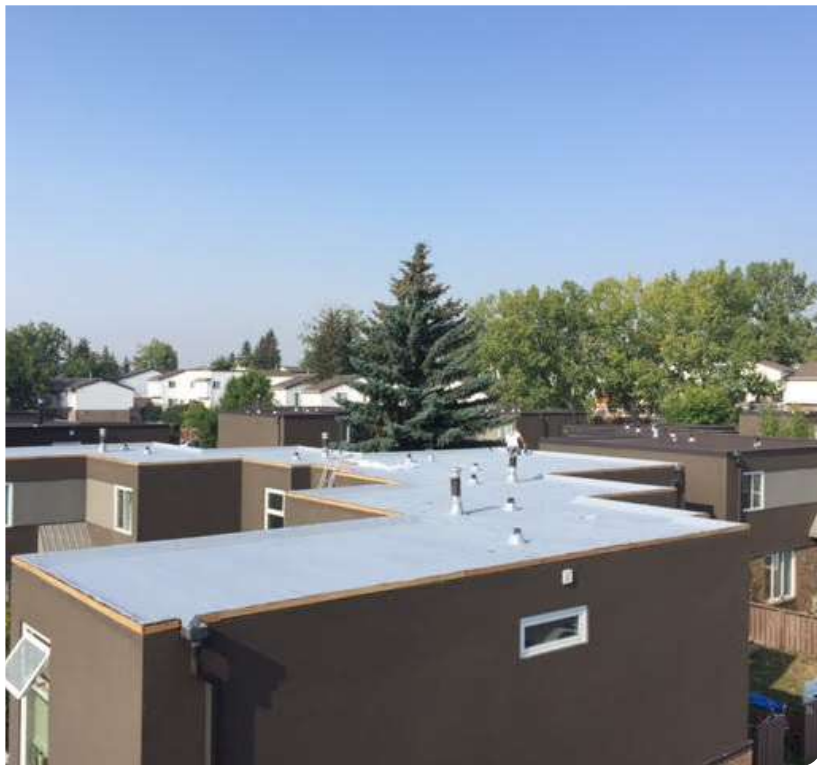
High tensile fabric is used in between base-coat layers 1 and 2. It gives the system structure, added flexibility, added adhesion and creates a blanket over the entire roof.

The fabric is always laid out in the opposite direction of the SBS seams. After the fabric has been immersed into layers 1 and 2 and has cured, you can inspect the layers for deficiencies and flood any areas that require extra material.

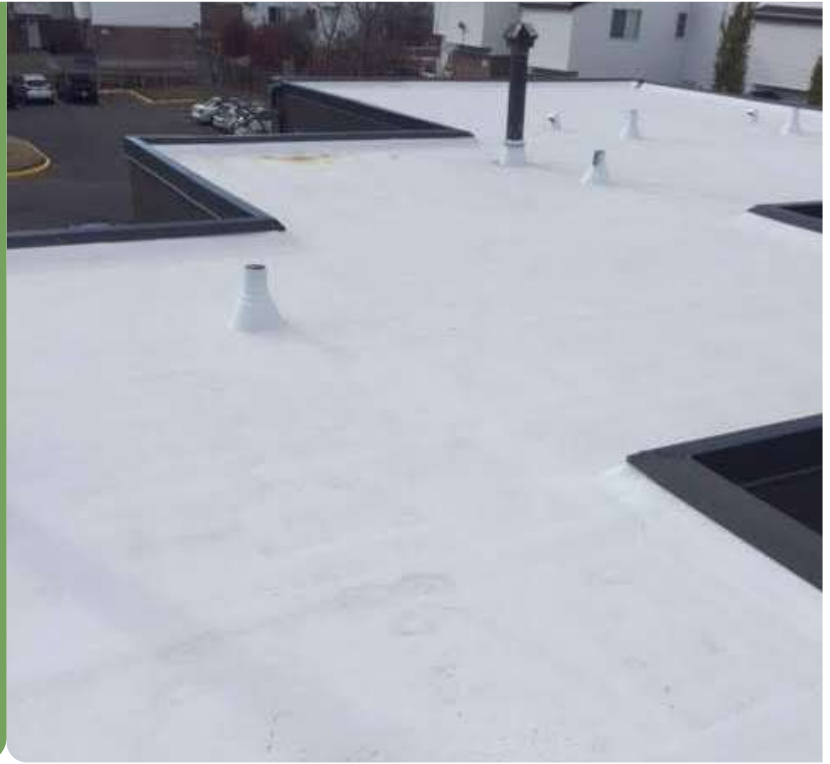
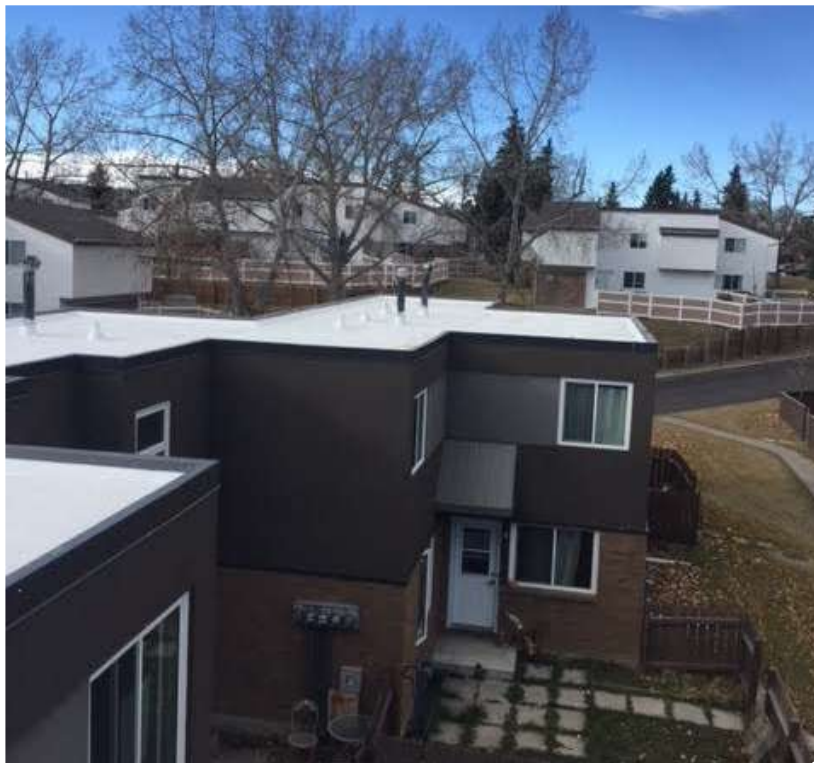
All layers of the membrane carry up the roof's perimeter and over the edge, ensuring your protection doesn't stop at the flashing. All the terminations essentially become part of the roofing system itself as they are incorporated into the coating. This leaves no potential trouble-spots and adds extra security against snow build-up and ice-dams forming.

The flashings were re-installed just in time. The next big rain-storm was on the way that very day and not a drop of water passed through the new roof, keeping the residents happy and dry.
